City of Ann Arbor
Guy C. Larcom City Hall
301 E. Huron St.
Ann Arbor, Michigan 48107

Re: West Park Band Shell
Phase II: Foundation Exploratory Excavation – Conclusions and Recommendations

HRC Job No. 20210331.02

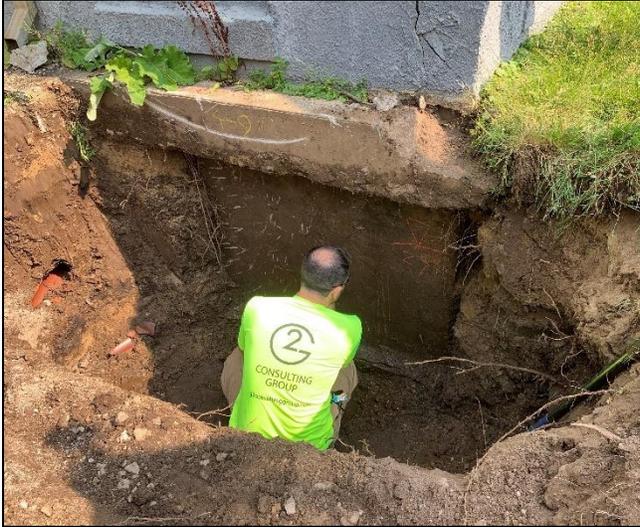
- Full height wall crack in parging noted about 16" west from east corner. Nominal crack thickness was about 0.016 mils. Moisture weeping thru crack in a small steady stream.

- Ground water flowing around the wall corner starting from about 2' below grade to bottom of the excavation.
- Abandoned sanitary line noted below bottom of footing and about 3'-4" from wall corner.

- Abandoned collapsed clay foundation drain project out at about 75 degrees from face of wall.
- No delaminations within the parge coating were noted.
- Several smaller cracks noted throughout excavated wall face.

- Ground water is flowing from underneath the concrete footing.
- Excavated material – wet silt sand with some organics and trace of gravel.
- Clay tile foundation underdrain parallel to the wall face does not exist.

- Concrete perimeter curb at grade – full depth crack noted and matches location of corner crack in wall section above.
- Ground water elevation is above the foundation frost line.

Photo 1: Southeast Corner

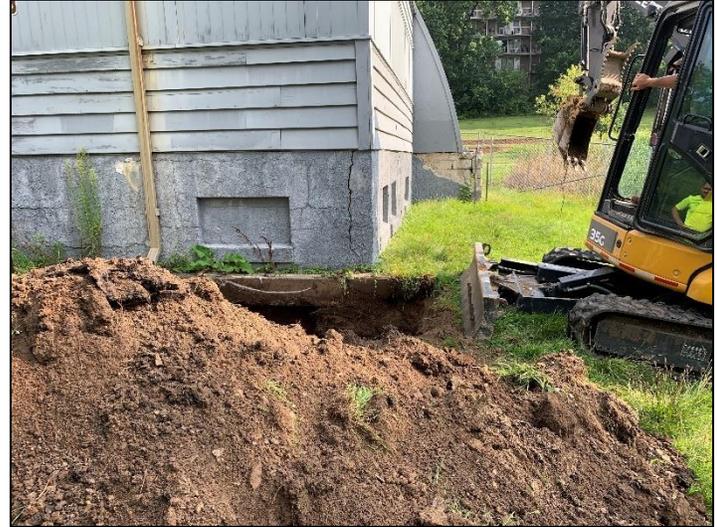
Photo 3: Weeping Corner Wall Cracks

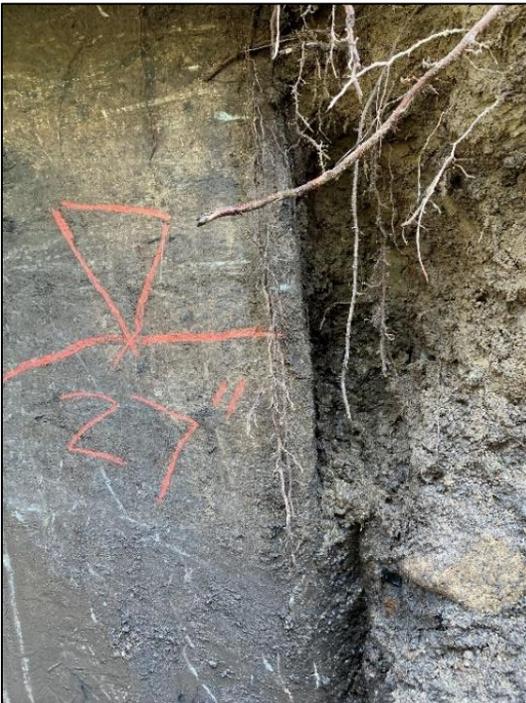
Photo 2: High Ground Water Table at 27" Below Grade

1. At the time of investigation, the ground water table inside and outside the building foundation was approximately 2' below grade. Perimeter foundation underdrains were not originally installed. Cracks within the parging waterproofing protective coating have permitted groundwater submergence of the block walls since about 2003. This prolonged submergence has likely caused the Portland Cement material component of the block to become compromised resulting in a loss of the block wall's structural integrity.

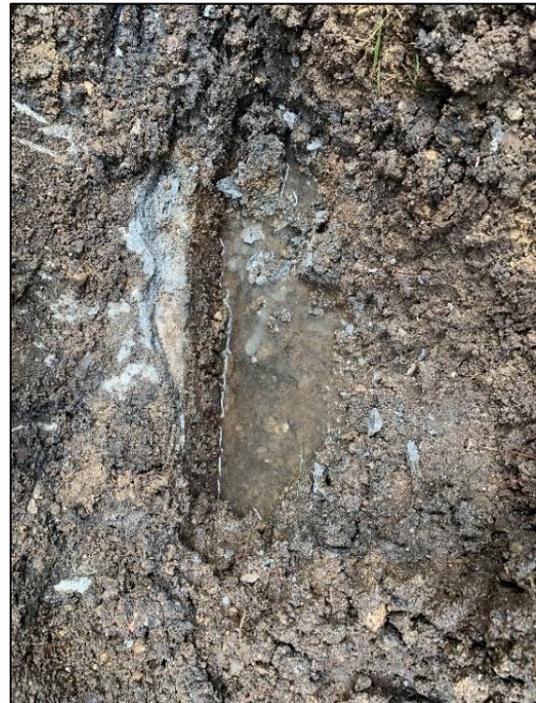
Photo 4: Saturated Top & Local Erosion Below Footing

the bottom of footing causing local erosion. Knowing the amount of observed flowing ground water and soil saturation around the footings we would expect other local areas of erosion directly below the bottom of the concrete footings. The potential loss of soil bearing pressure from the footing underside is a structural concern.

Based on the above stated conclusions and understanding that preservation of the historical character of the bandshell and adjoining building are the City's primary objective, we recommend that the existing foundations be replaced. Two different foundation replacement approaches for consideration are as follows:

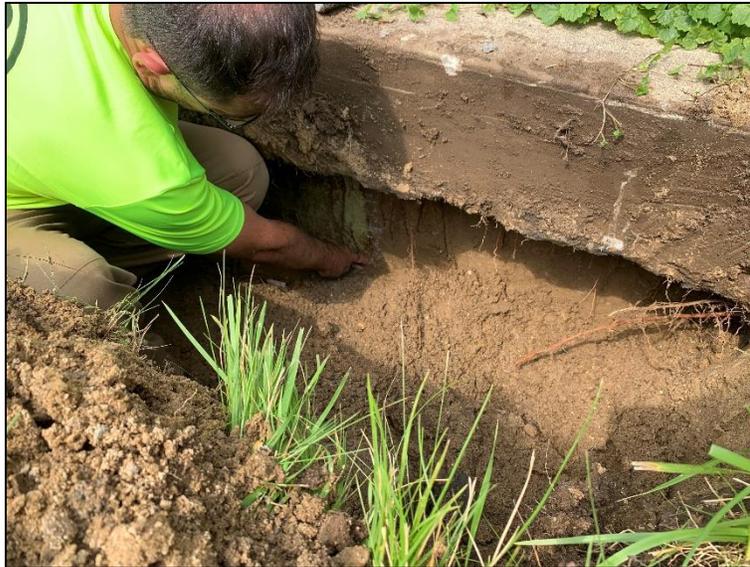
- Nominal excavation area: 2' height by 3' length by 2' wide.
- Door opening was closed off with a masonry block infill and waterproofed.
- Excavated material – very wet fluid sand backfill material. 100% saturated.
- Several hairline cracks noted in waterproofing cementitious coating.
- Ground water level about 10" higher than that at Test Pit #1.
- Original stairs return wall, off the building corner, was removed (consistent with 1993 construction).
- No delaminations noted in the cementitious waterproofing coating.
- An existing hole that measured about a 1" in diameter was noted at the interface between the original and infill masonry block. Deterioration of the infill block was also noted.
- Ground water elevation is above the foundation frost line.

Photo 5: Along East Wall

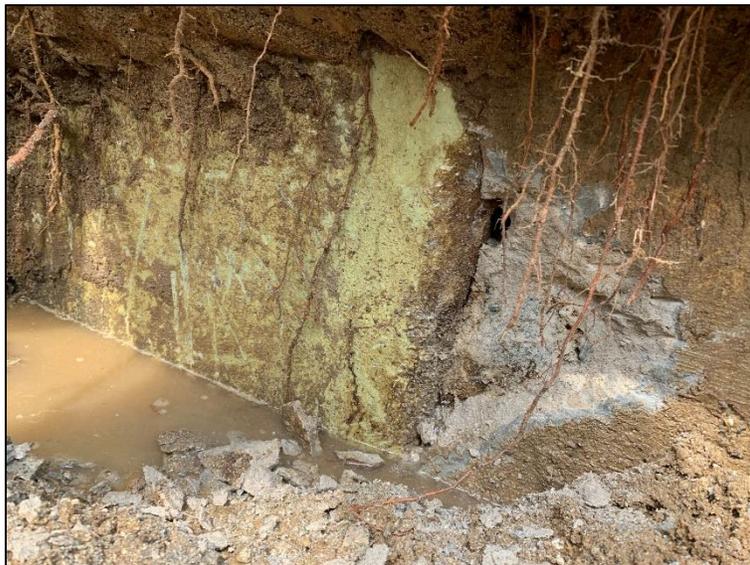
Photo 6: Damaged and Saturated Door Infill Area

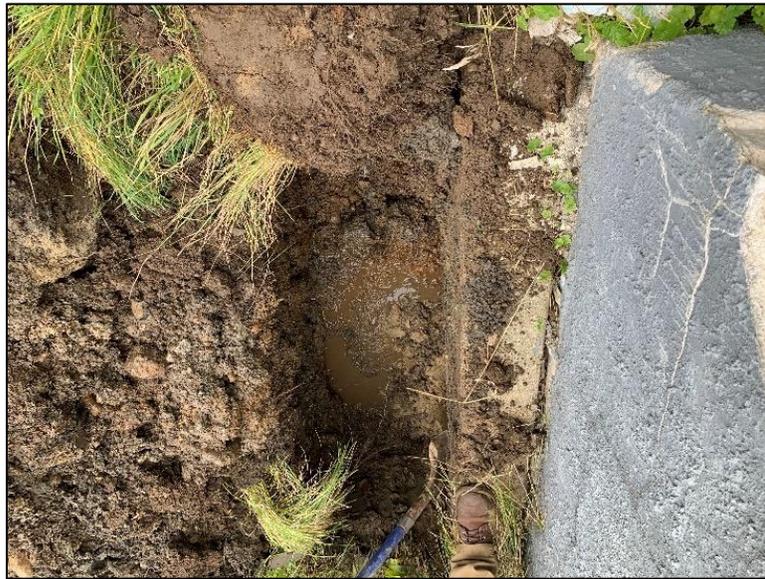
- Nominal excavation area: 1' height by 2' length by 2' wide.
- Extensive flowing ground water noted at the face of wall and flowing thru the wall cracks.
- Excavated material: very wet fluid sand backfills.
- Ground water surface measured about 1.5' below the perimeter of the concrete curb.
- Steady stream of moisture thru the block wall was noted.
- Ground water elevation is above the foundation frost line.

Photo 7: Plan View of Northeast Wall Corner: Saturated Soils and Local Erosion

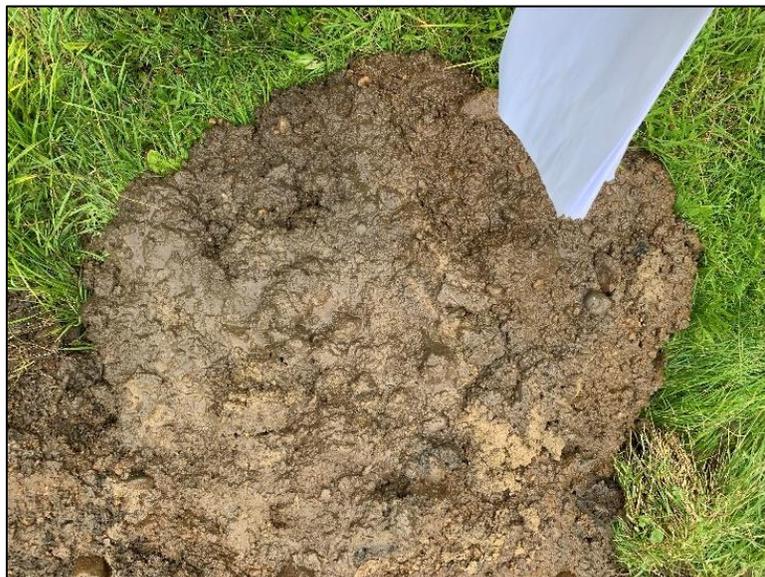
Photo 8: Saturated Excavated Spoil
