City of Ann Arbor
Guy C. Larcom City Hall
301 E. Huron St.
Ann Arbor, Michigan 48107

Re: West Park Band Shell
Phase II: Foundation Exploratory Excavation – Conclusions and Recommendations

HRC Job No. 20210331.02

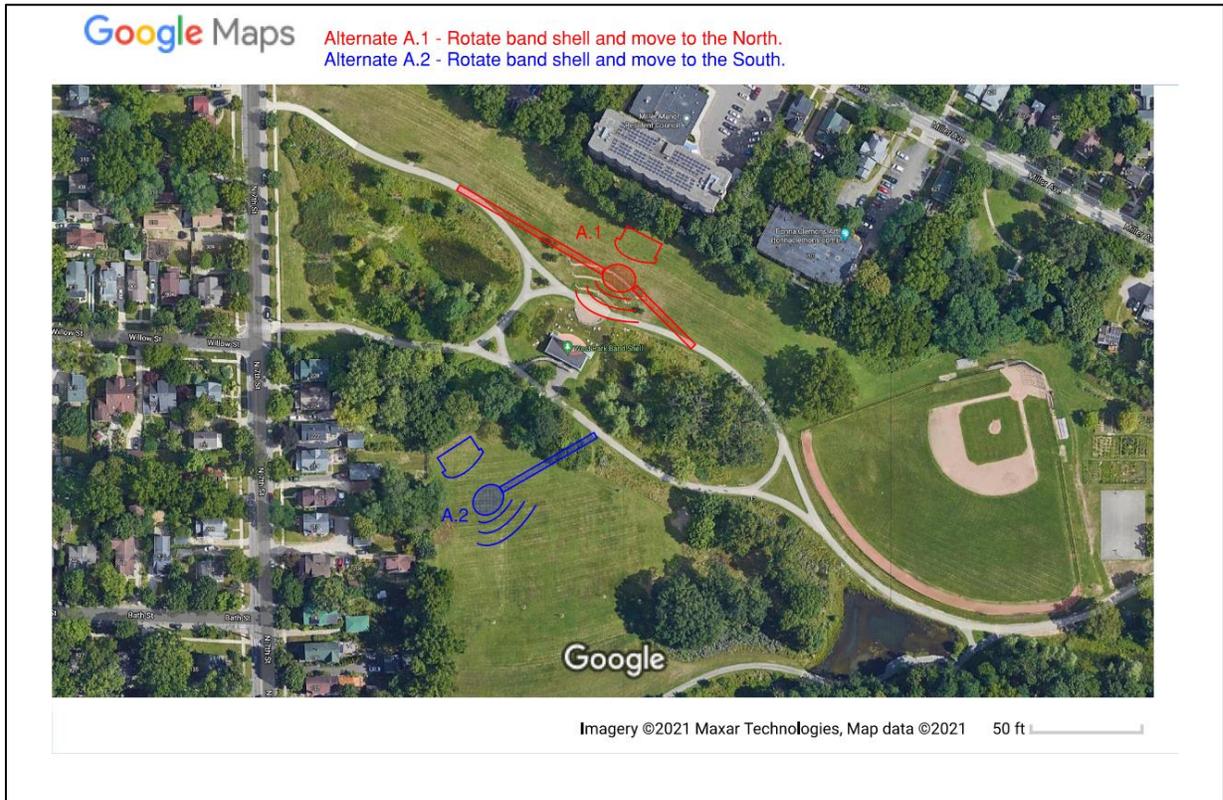
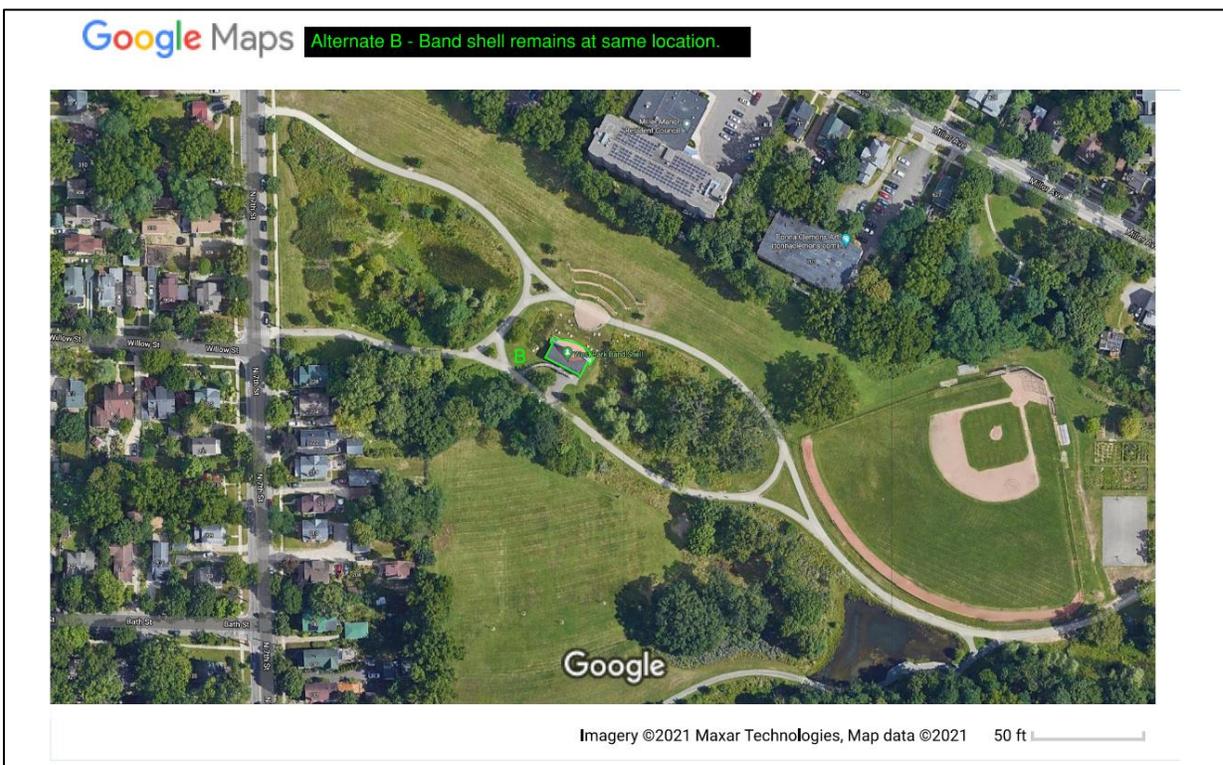
Alternate A - Potential Relocations:

The bandshell and adjoining building would be temporarily jacked and shored, transported to a location close to the existing but outside of the 100-year floodplain, (see attached Site Location A.1 & A.2), and positioned on new cast in place concrete foundations. The structure would likely be temporarily separated into four main sections for transportation, two for the conical bandshell arch (arch bandshell & sloped roof) and two for the adjoining building (east & west half). Soils information recently acquired indicate that conventional retaining wall style foundations would be appropriate and deep foundations would not be warranted in the new location. The new above ground foundation appearance could match the existing or be slightly different pending the City's needs for maintaining the historical character of the structure. Implementing this alternative would require a specialty building moving contractor and providing a temporary transporting road to the structures' new location. Audience seating could be similar or different and a separate restroom facility could be constructed pending the City's needs. Relocating the structure to a new location close to the existing but outside of the floodplain, we would anticipate the life expectancy of the new foundations to range from about 50 to 75 years. One advantage of Alternate A is that the structure and seating area will be above the 100-year floodplain and the surrounding soils will not remain saturated. One disadvantage is that during relocation efforts the historical structure may be susceptible to damage. As with any rehabilitation project, contingencies should be included for unanticipated / unintended costs. However, this approach would minimize that risk. Anticipated conceptual cost estimates for this alternate are as follows:

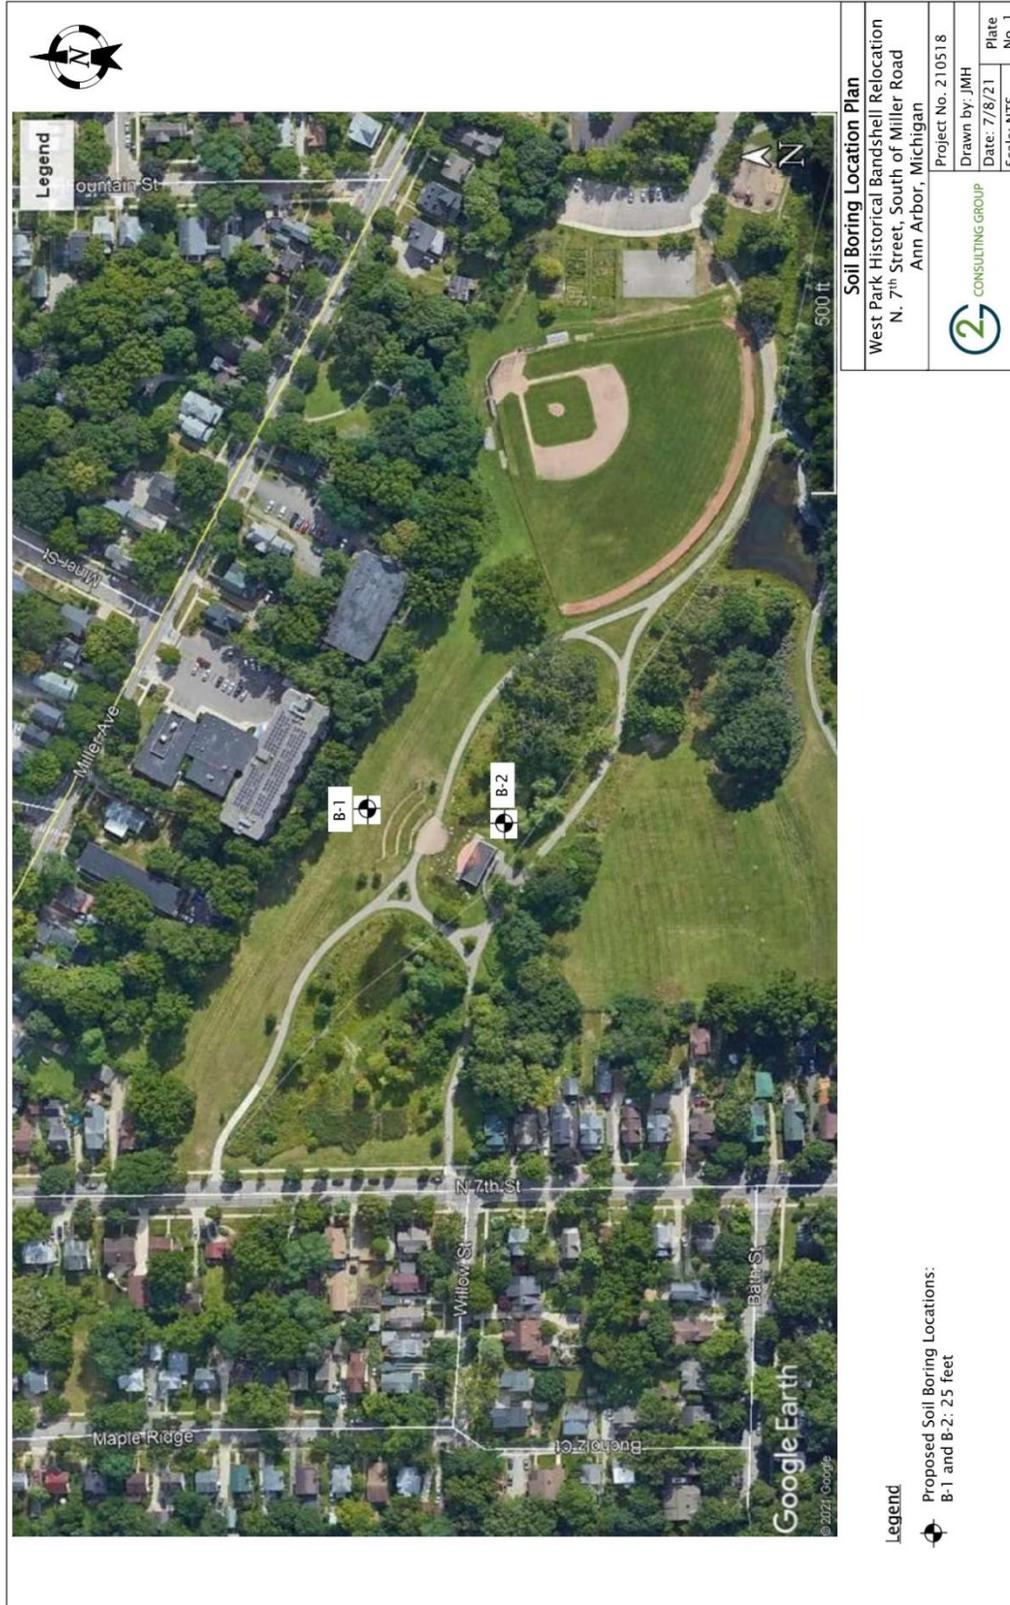
Soil Borings:

G2 Project No. 210518									
Latitude: N/A Longitude: N/A									
SUBSURFACE PROFILE		SOIL SAMPLE DATA							
DEPTH (ft)	PRO-FILE	GROUND SURFACE ELEVATION: N/A	DEPTH (ft)	SAMPLE TYPE-NO.	BLOWS/6-INCHES	STD. PEN. RESISTANCE (N)	MOISTURE CONTENT (%)	DRY DENSITY (PCF)	UNCONF. COMP. STR. (PSF)
		Topsoil: Dark Brown Silty Clay with trace sand and gravel (18 inches)	1.5		3				
		Fill: Brown Silty Sand with trace gravel	2.0	S-1	1	3			
		Buried Peat: Soft Very Dark Brown Organic Silt with trace sand, light gray marl inclusions	3.0		2				
5		Loose Brown Silty Sand with trace gravel, occasional soft gray clay seams	5	S-2	4 4 6	10

6.0		Loose Gray Sandy Silt, occasional clay seams	6.0	S-3	3 2 3	5			
8.0			8.0						
10		Medium to Stiff Gray Silty Clay with trace sand and gravel, occasional sand partings	10	S-4	3 2 3	5			1600**
15			15	S-5	3 3 4	7			3000*
